METAL RETROFIT
MR | T1.6

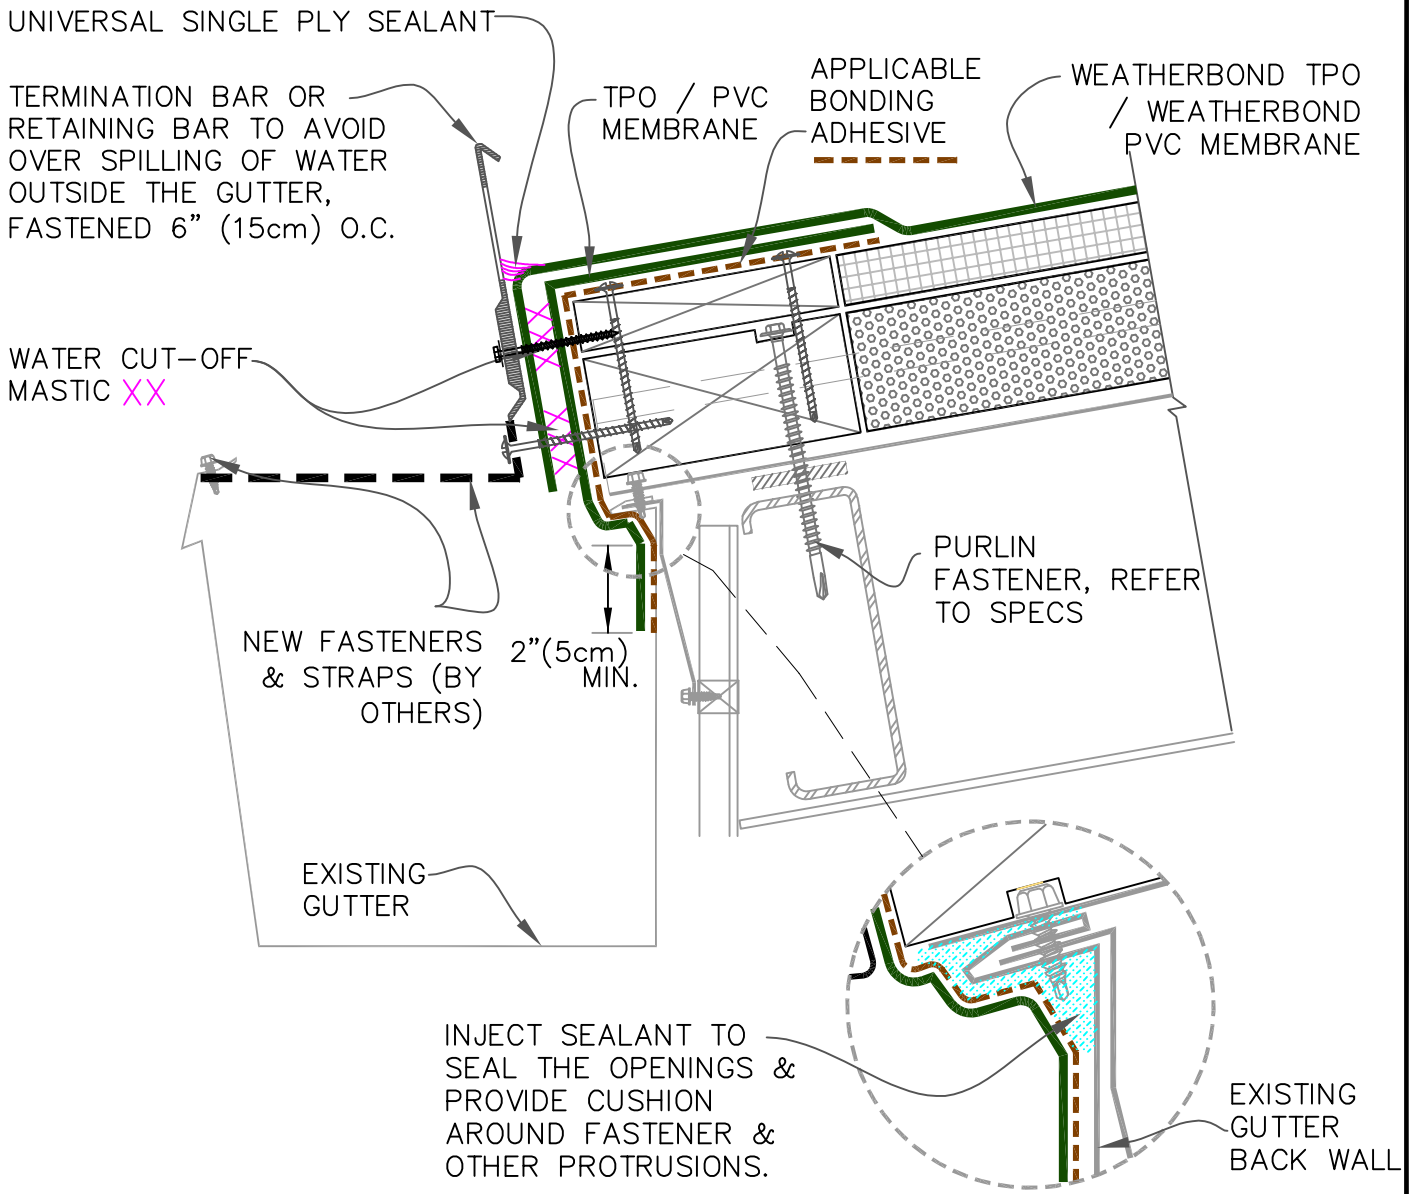
GUTTER WITH STRAPS ANCHORED INTO STANDING SEAMS

- HIGH DENSITY RECOVER BOARD
- IN-FILL INSULATION
- SEE NOTE(S)
